# Actions on MDPH Recommendations, Whitin Intermediate School, Uxbridge, MA

The following is a status report of action(s) taken on MDPH recommendations (in **bold**) based on reports from town officials, school maintenance staff, documents, photographs and MDPH staff observations.

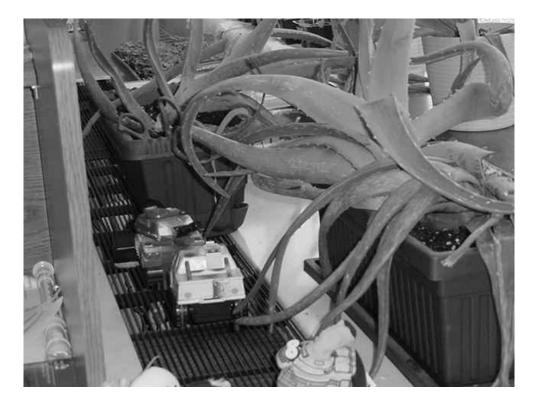
### Picture A-1

**Action:** Univents and exhaust vents were still found obstructed by various items throughout the building (Pictures A-1 through A-3).

**Action:** Plants were still observed on univents in classrooms (A-1 and A-7).

**Plants and Other Items on Univent**

Remove all blockages from univents and exhaust vents.

Move plants away from univents in classrooms. Ensure all plants are
equipped with drip pans. Examine drip pans for mold growth and disinfect
areas of water leaks with an appropriate antimicrobial where necessary.
 Consider reducing the number of plants.

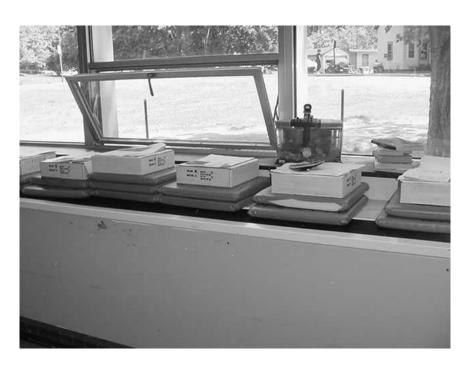
### Picture A-2

**Items on Univent**

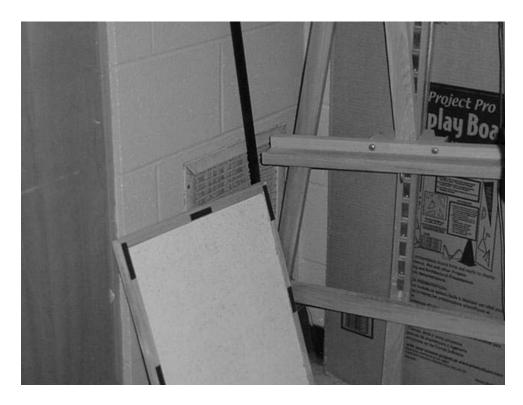
### Picture A-3

Wall-Mounted Exhaust Vent Obstructed by Various Items

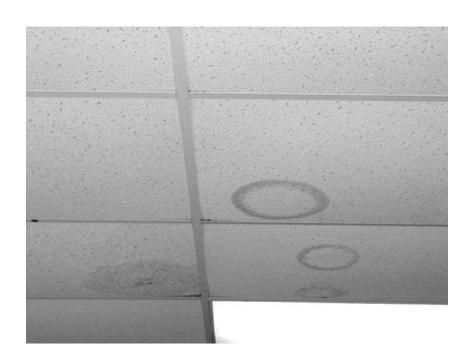
### Picture A-4

**Action:** Ceiling tile replacement is on-going; however, water damaged ceiling tiles were observed in a number of areas throughout the WMS (Picture A-4/Table 1).

**Water Damaged Ceiling Tiles**

Replace/repair any remaining water-stained ceiling tiles and building
materials. Examine the area above and around these areas for mold growth.

Disinfect areas of water leaks with an appropriate antimicrobial.

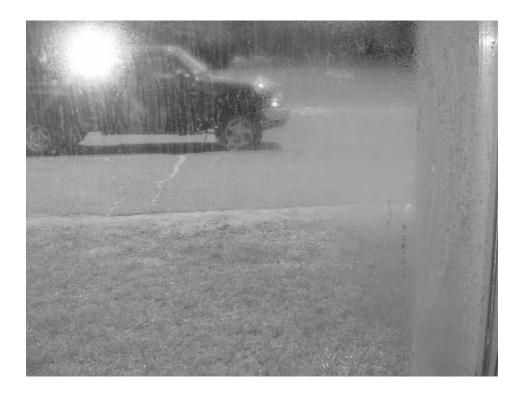
#### Picture A-5

**Action:** Windows seals were not replaced/repaired in several areas as evidenced by condensation between window panes (Pictures A-5 and A-6).

**Condensation between Window Panes**

• Repair/replace seals around window frames to prevent water penetration.

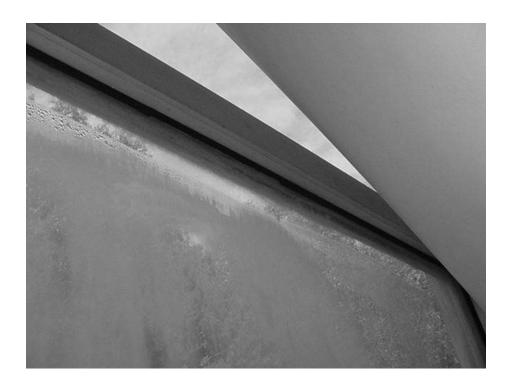
### Picture A-6

**Condensation between Window Panes**

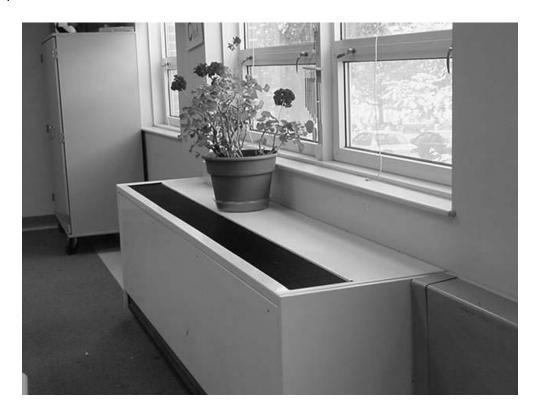
### Picture A-7

**Flowering Plant on Univent**

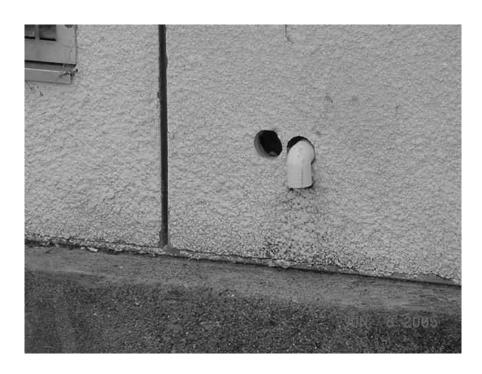
### Picture A-8

**Action:** Holes in exterior walls were not sealed (Picture A-8).

**Utility Hole in Exterior Wall**

Seal holes in exterior walls to prevent water intrusion.

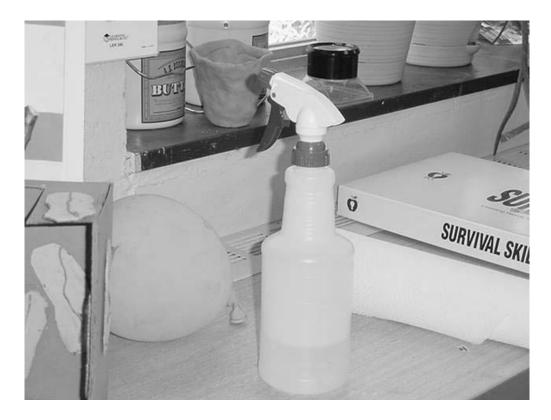
### Picture A-9

**Action:** Some classrooms still have improperly stored and unlabeled spray bottles (Picture A-9).

**Unlabelled Spray Bottle in Classroom**

• Store cleaning products properly and out of reach of students. Store flammables in a flameproof cabinet.

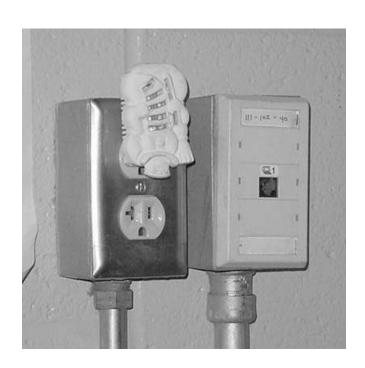
#### Picture A-10

**Action:** Air deodorizers were in use during the reassessment (Picture A-10).

Plug-in Air Freshener

Refrain from using strong scented materials (e.g., air fresheners) in classrooms.
